A tale of two bridges: the Iron Bridge and Coalport Bridge, Shropshire

Andrea Parsons and Shelley White

ABSTRACT: The Iron Bridge (SAM Salop 106), built in 1779, and Coalport Bridge (SAM Salop 341) built in timber in 1780, rebuilt in 1800 and again, in iron, in 1818, span the River Severn in the World Heritage Site of the Ironbridge Gorge. They were surveyed from 1999 to 2001 and 2001 to 2004 respectively. The Iron Bridge proved to be a palimpsest of minor and major repairs. The Coalport Bridge survey highlighted the apparent lack of alterations to the ironwork of 1818, whilst supporting the documentary evidence for the three major phases of construction in the bridge's history. Despite this, both structures retained some similar major component parts albeit comprising individual methods of construction. Evidence from both bridge surveys pointed to advances in the understanding of bridge construction from the eighteenth to the nineteenth century.

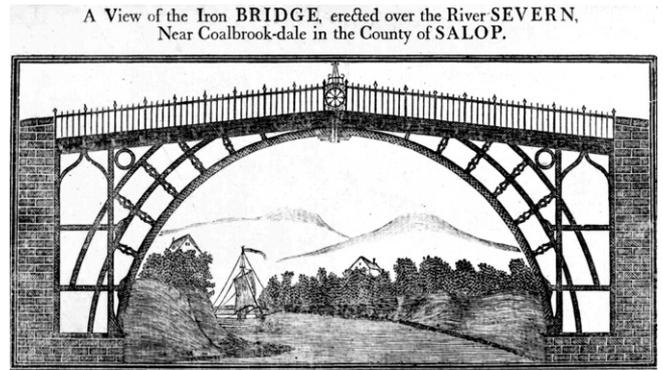
Figure 2: An early wood-cut of the Iron Bridge. (Ironbridge Gorge Museum Trust - CBD 1981.20)

The general form of the Iron Bridge is clear from its appearance (Fig 2), and was described in detail by Hume (1980). Despite this basic understanding of the bridge’s known components, examination in 1999 showed that further interpretation of the relationships between components was required (Fig 3).

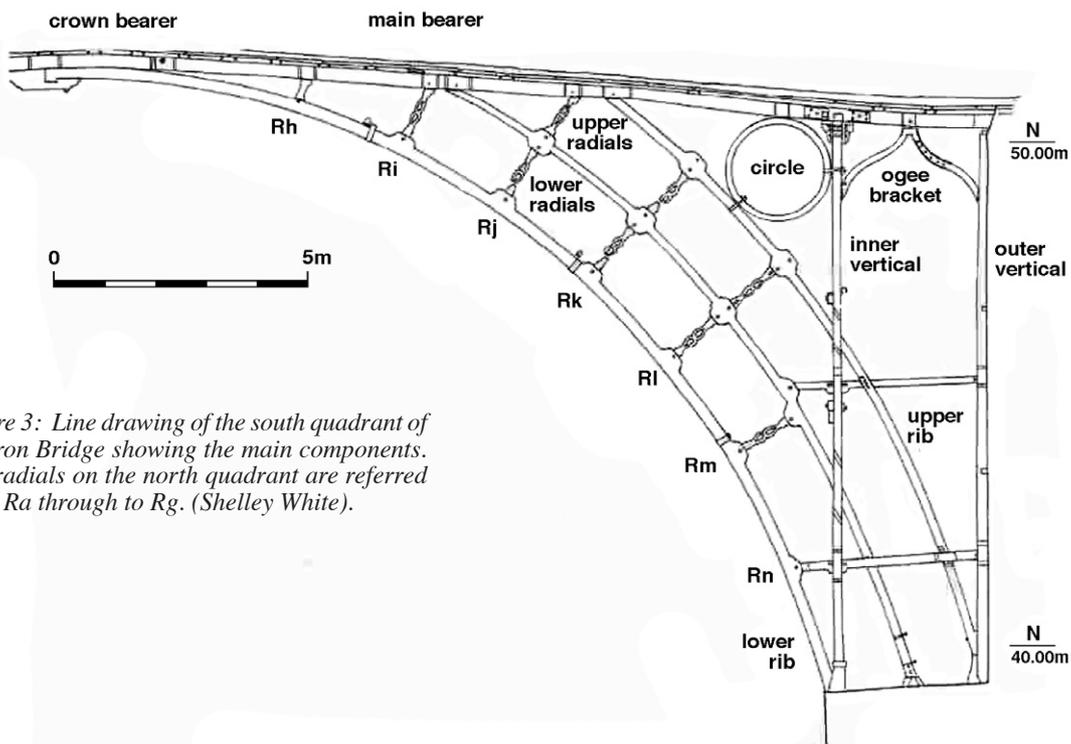
Figure 3: Line drawing of the south quadrant of the Iron Bridge showing the main components. The radials on the north quadrant are referred to as Ra through to Rg. (Shelley White).

Originally wholly constructed from cast iron components, the substructure comprised five semi-circular frames (A–E: upstream to downstream), each comprising a north and south quadrant. Further components, the lower rib, upper rib, radials, vertical and flanged bearers formed the substructure to the main arch. These components were cast to form interlocking joints, or were surrounded by the sandstone abutments (Fig 3).

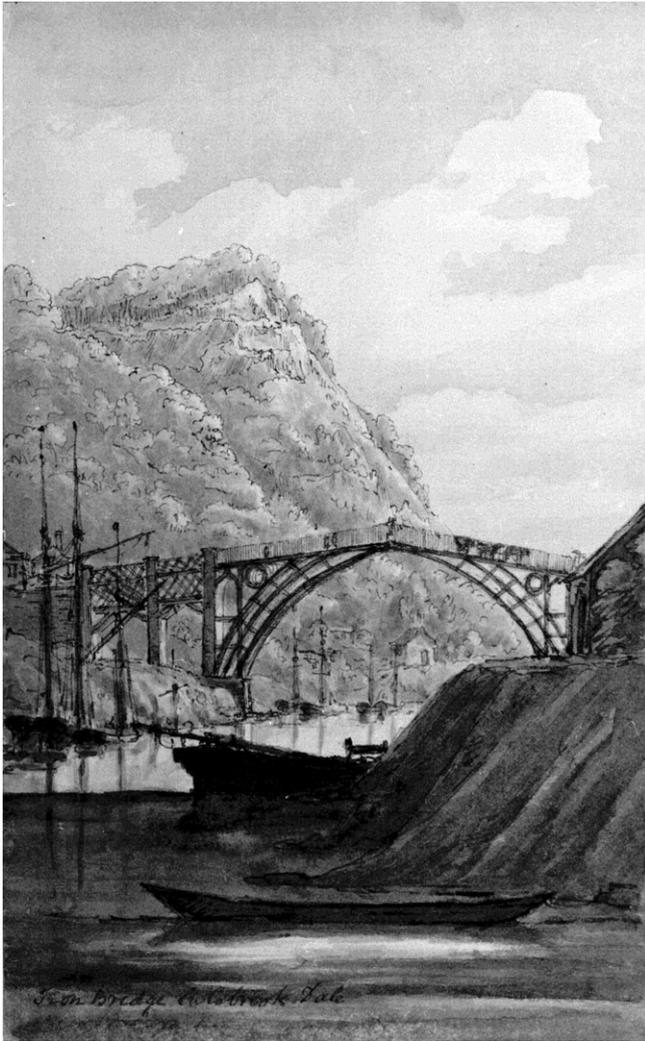
Figure 4: 1804–21 Pencil sketch showing the first large-scale alteration of the bridge with wooden trellis arches in the South Abutment. (Ironbridge Gorge Museum Trust – CBD 1978.225).

The bridge originally comprised a single main arch, supported by the substantial north and south masonry abutments, each housing a small accommodation arch allowing the passage of traffic on the riverside toll path (Fig 12). By 1804 the southern masonry abutment was altered by the construction of the inner and outer south arches, alleviating structural strain. Originally both these arches were of trellis wood construction (Fig 4).

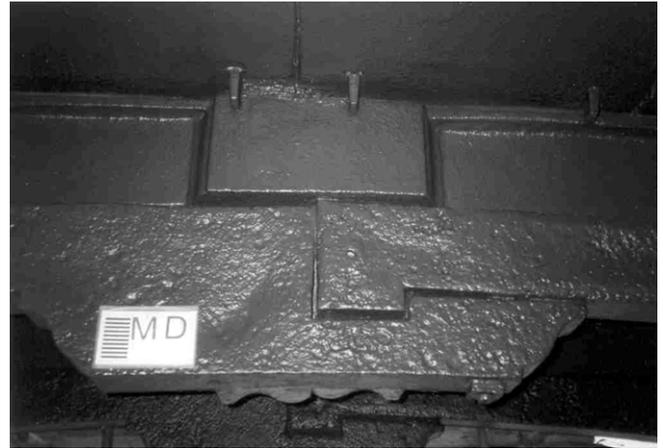
Figure 5: The rear view of the crown which locks all the major components together, thus guarding against vertical and lateral movement. These components clearly show the up-cast and down-cast faces of the ironwork (Ironbridge Archaeology Archive – F13/8).

examination the crown joint was found to be a fully-housed longitudinal lap joint, bolted across the lap, with an additional lap joint forming the false ‘key’ feature. To the rear of this sat a bevelled mortice, which fits into a half-housed tenon on the crown bearer (Figs 5 and 6). The complexity of the joint was due to its purpose, *ie* to hold together the north and south quadrant lower ribs, forming a stable centre point with load-carrying ability. In the 1980 report no relationship was given between the lower ribs A and B, and the crown bearer C.

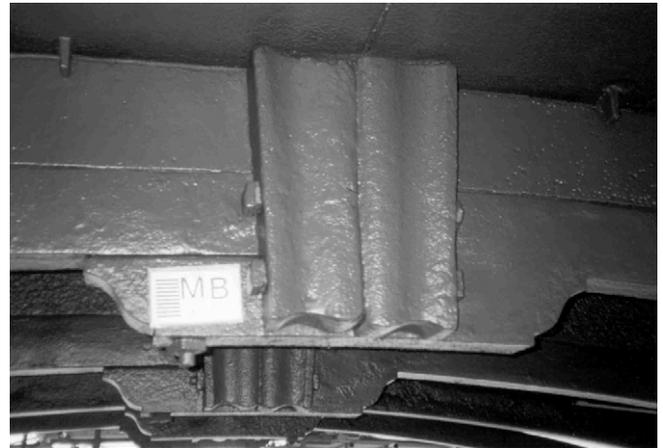
Figure 6: A front view of the crown joint showing the crown bearer and upper ribs A and B (Ironbridge Archaeology Archive – F9/10).

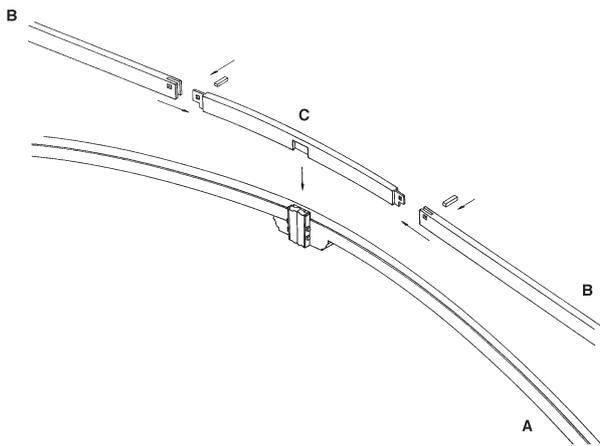
Figure 7: A line drawing showing the relationship between the component parts. Part A is the upper rib, B is the two main bearers per frame and C is the crown bearer. (Shelley White)

Prior to this survey, the bearers were each thought to be individual single castings, forming the upper extent of the south or north quadrant. However, previously unobserved joints to either side of the crown joint created a new component; the ‘crown bearer’ which sat upon the lower ribs (Fig 7). This was a single curved open-floor casting which sat equally above the central terminal of the lower ribs of the north and south quadrants. Either end of the crown bearer was connected to the main bearer with a longitudinal dovetail, and located in place with wedges and pegs (Fig 8). The gentler curvature of the ‘crown’ bearer reduced the bridge’s curved profile, assisting the positioning of the roadway components.

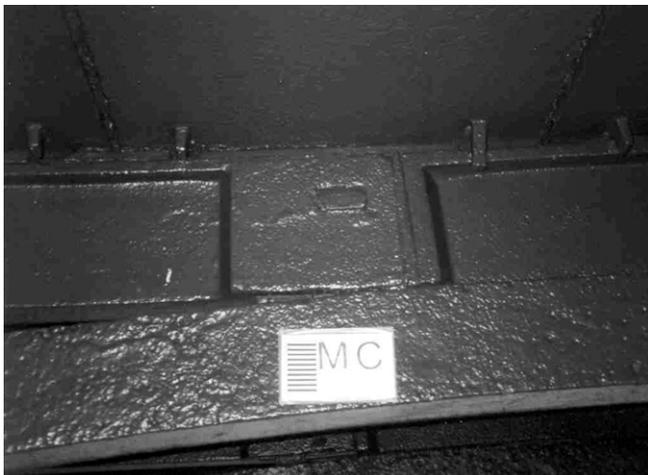
Figure 8: A view of the crown bearer to main bearer joint (Ironbridge Archaeology Archive –F11/19).

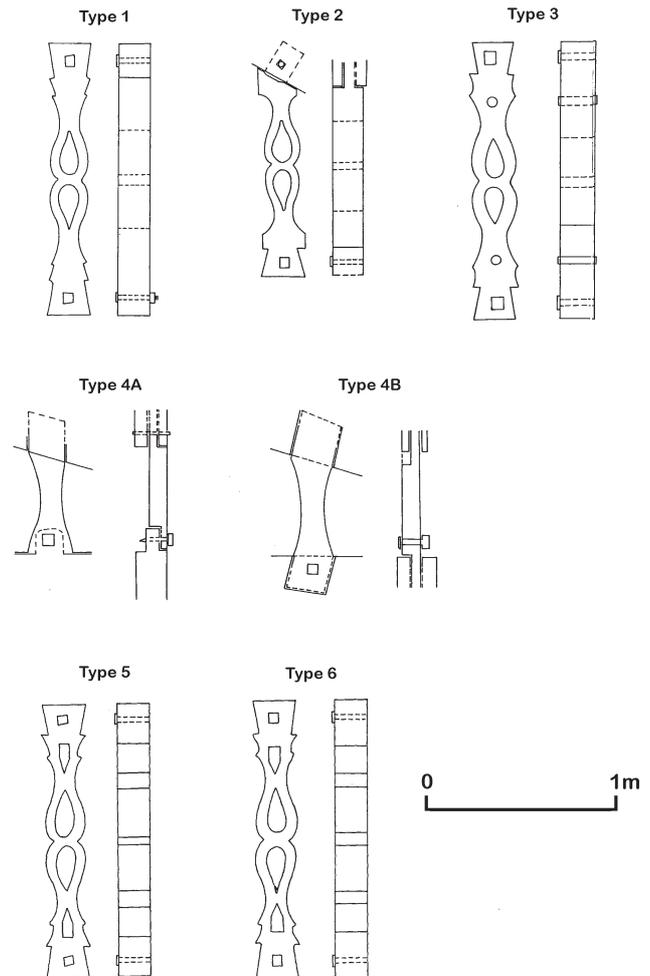
Figure 9: The typology of upper and lower radials

The typology encompassed all 90 radials, and was set up on site with regard to form, dimensions and casting technology. Six types of radials were identified, each with distinguishable yet subtle features (Table 1, and Figs 9 and 10); from these, two other typologies were derived; a structural typology taken from the location

Type 1	Original sand-cast radial
Type 2	Original sand-cast 3/4 sized radial
Type 3	Robust flask-moulded radial cast with two mould gates
Type 4A	Later addition/repair small half-radial
Type 4B	Thought to be an original small sand-cast radial
Type 5	Thin sand-cast radial
Type 6	Thin sand-cast radial

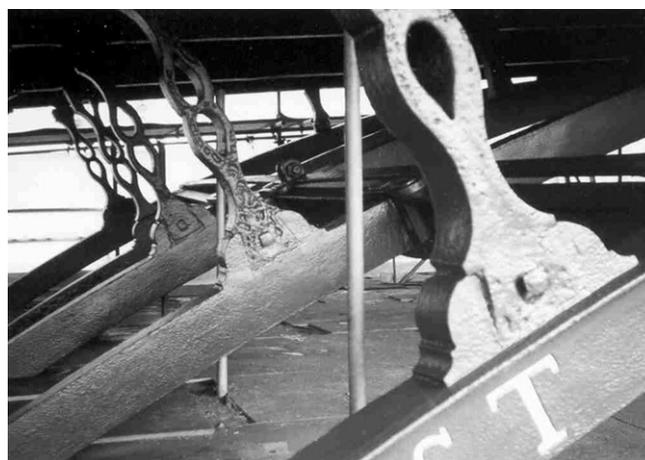
Figure 10: A view across the five frames of the bridge, showing at least two of the differing radials.

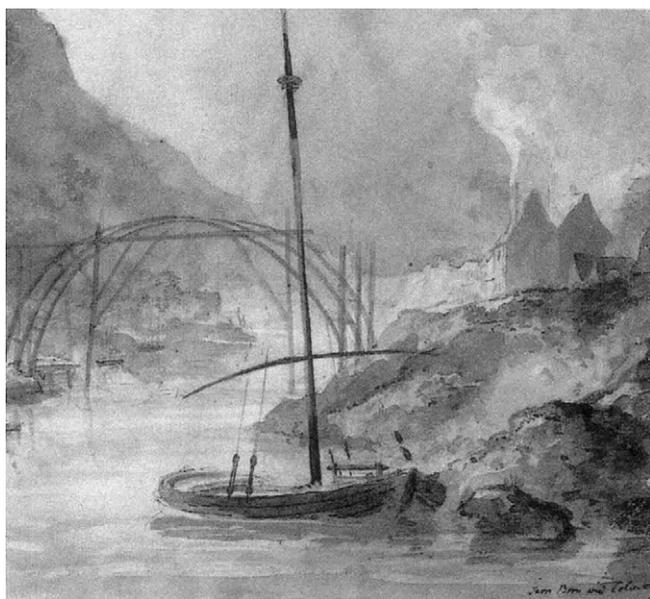
Figure 11: The Martin sketch identified two standing derricks with a cross bar: in essence forming a simple crane. (Skandia Insurance Company Ltd, Stockholm, Sweden, photographed by Ake Cyrus).

This information was linked to new documentation on the erection of the bridge. In the past, a number of theories for the raising of the frames have been suggested, each involving a large amount of preparation work (Hodson 1992, 37–41). Examination of the small Elias Martin watercolour sketch re-discovered in 1997 (Fig 11), provided a new hypothesis for the raising of the frames. Martin illustrated a single lightweight derrick construction by which three of the five frames (A,

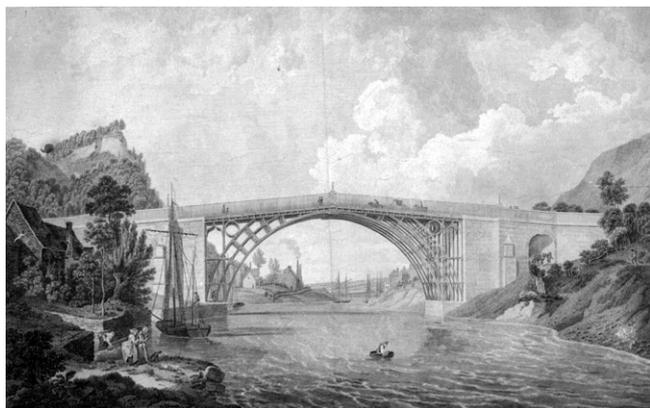
Figure 12: The Cast Iron Bridge near Coalbrookdale by Michael Angelo Rooker (Ironbridge Gorge Museum Trust – CBD 59.85.3)

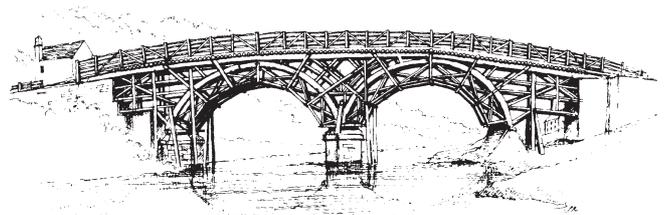
Figure 13: Sketch of the wooden Preen's Eddy (Coalport) Bridge c 1789 by J Farington.

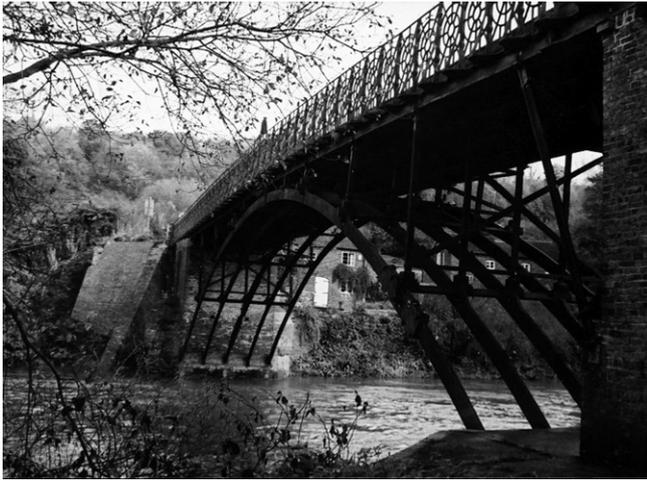
Figure 14: View of Coalport Bridge from the west.

The span of the bridge is composed of five cast-iron ribs in two sections (Fig 14). The ribs of the centre span have eight vertical cast iron frames (spandrel frames) placed symmetrically along the north and south half ribs with an additional raking brace support spanning the gap between the south pier and the deck above. Five cast iron deck bearers in the form of inverted 'T' beams are supported on the vertical frames and these in turn support cast iron deck plates (four across) which overlie the bridge structure and form the base of the roadway. The bearers and deck plates extend from the centre span over the north and south brick piers, and then cross the approach spans to continue for a short distance into the roadway. Cast iron parapets constructed of panels with circular motifs run the length of the bridge on each side. Each parapet elevation has a central panel with a decorative semi-circular crest with the inscription 'Coalport Bridge 1818' and the initials JO (John Onions) in the centre (Fig 15).

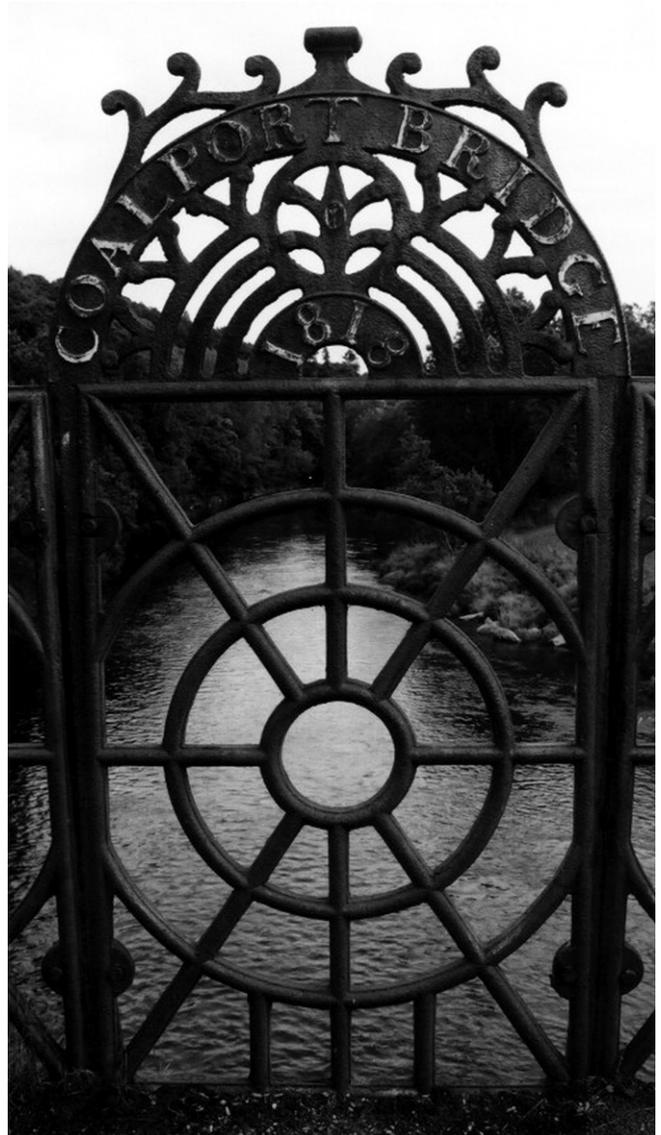
Figure 15: The centre panel of the bridge parapet with initials of John Onions, who supplied the ironwork for the 1818 bridge.

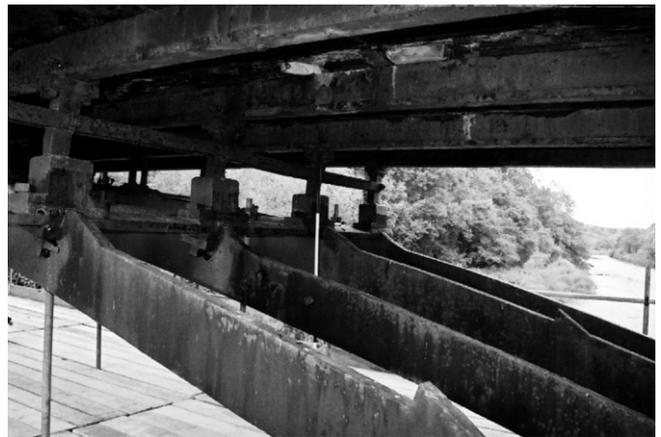
Figure 16: Ribs 2, 3 and 4 showing the redundant lugs of 1800.

Ribs 2, 3 and 4 on the south side and ribs 2 and 4 on the north side have a common feature: the presence of angular lugs projecting from the upper edge of the ribs, which became redundant in the 1818 re-design (Fig 16). These fin-shaped lugs are placed in a consistent pattern along each of the ribs in question, and are located between the base plate and outer spandrel frame, between the outer and middle spandrel frames, between the middle spandrel frame and the second transverse brace and between the second and first transverse brace. The lugs always face towards the crown joint. However, no lugs are present on ribs 1 and 5 and the northern half of rib 3, all of which are considered to be later than the ribs with lugs.

The lugs are small, averaging 205mm long by 76mm high and follow the thickness of the rib. They form an approximate right angle with the rib being at slightly less than 90°, and it would seem that, whatever form

of vertical framing they located onto the rib, they were not designed to act as a joint like the double-lugged transverse joints elsewhere on the ribs. These rather insubstantial features may have simply positioned a horizontal beam with vertical posts similar to the present spandrel frame design. Related to the redundant lugs are the double-lugged shoulder joints on ribs 2, 3 and 4 south and 2 and 4 north, which have a different character to those on the 1818 ribs.

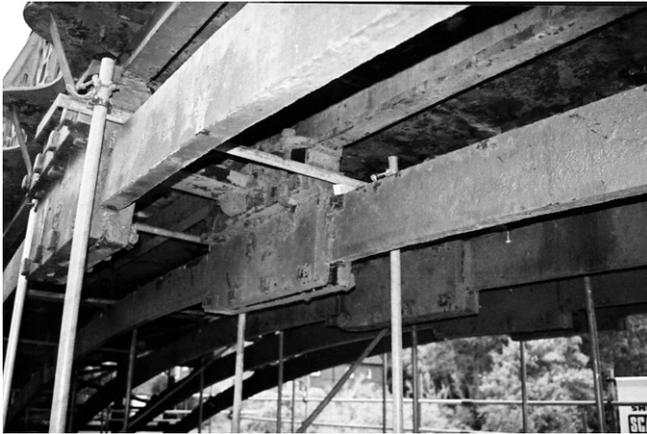
Figure 17: Fishplates connecting the centre span ribs.

The crown joints of Coalport Bridge are relatively straightforward when compared with the complicated 'false key' crown joints on the Iron Bridge. Each joint is formed from two cast iron plates placed on either side of the ribs to cover the join where they meet at the centre (Fig 17). These are bolted together, and have flanges at the top in order to connect with the central transverse tie beam and deck bearers above. The connections from the fishplate flanges to the bearers have a range of variations, some of which relate to chronological changes and some of which are a response to the defects and anomalies found in the bearers and joints. It is clear that the original connectors (1800 phase), which ran from the fishplate flange upwards into the bearer flange, have been altered or replaced. Crown joints 2 and 4 have a similar mix of connectors, several of which have been altered as a response to earlier iron being left in the receiving holes of the posts. This indicates that an earlier form of fixing was used in 1800 and was replaced or altered when the bridge was rebuilt in cast iron in 1818. In addition to this are the faint imprints or 'shadows' on the faces of the fishplates, of the original fixings that took the form of iron wedges rather than bolts. Curiously these wedges are still in place in crown joint 3, an anomaly which is hard to explain, considering that the joint must have been taken apart to receive the new north half rib,

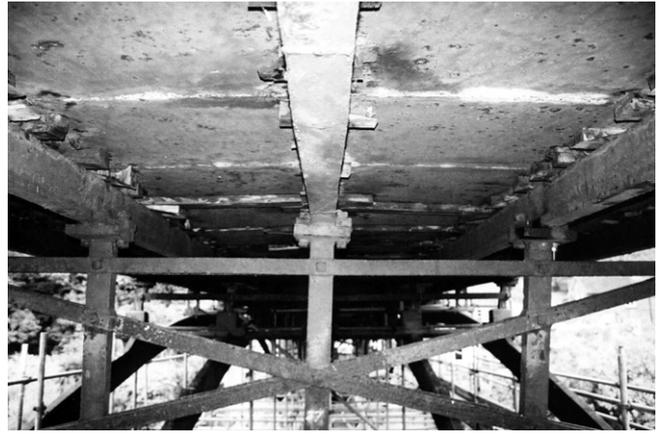
Figure 18: Typical inverted 'T' beam bearer, supported by the spandrel frames transverse tie beams.

Each of the five cast-iron deck bearers is made up of four sections, two primary bearers spanning the centre span and two secondary bearers spanning the approach spans (with a third short length of bearer on the south side). The bearers, in an inverted 'T' beam form, had two types of casting marks on them: a ridge across the bearer flange ('wave') and a domed 'button' which in some instances had corroded, leaving a void in the bearer itself (Fig 18). The cause of the wave marks was thought to be due to the bearers being cast in a two-piece closed mould (known as a 'cope and drag') or a sand mould with a 'lid': lengths of the lid were roughly butted up, allowing a small up-swell of cast iron (under pressure) which formed a ridge when

cooled. The cause of the button marks was probably the result of a 'whistler' or vent hole in the cope (top section of the mould) to allow hot gases and steam to vent off during casting; the pressure build-up during the process sometimes left a void behind the cooled protrusion. The bearers are connected to each other and the spandrel frames by flanged plates bolted to each other.
